# Flexural Behavior of Steel–concrete–steel Sandwich Slabs

Original Research Article

**Aims:** Study the flexural behavior of steel–concrete–steel sandwich slabs.

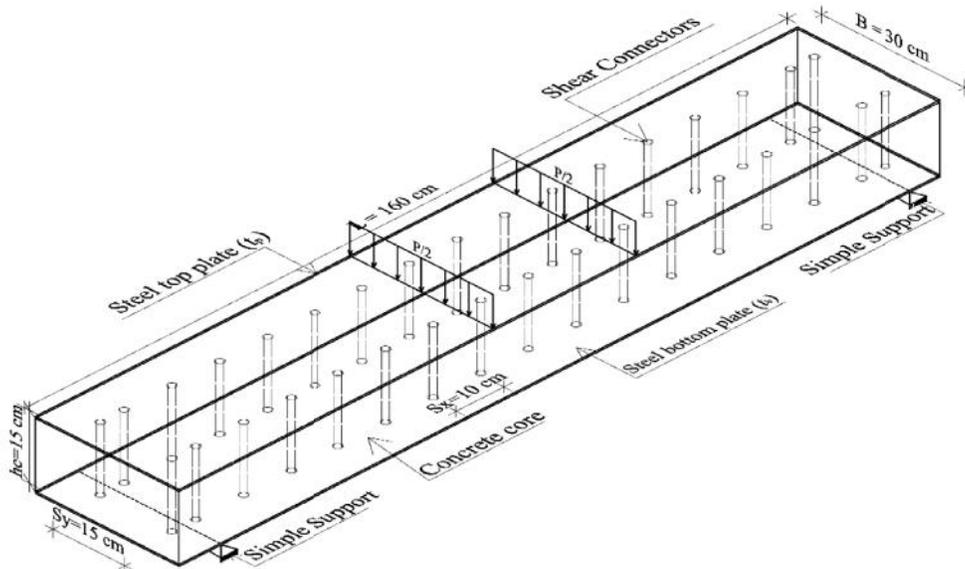
Fig. 2. A typical layout of studs and the relevant details of specimens

the performance of shear connectors to be studied exclusively. Of the five specimens identified in the text as DSC 4-4-S1 to DSC 4-4-S5 and the other five specimens identified in the text as DSC 6-6-S1 to DSC 6-6-S5. Five specimens DSC 4-4-S1 to DSC 4-4-S5 were fabricated with top and bottom plates of equal thickness of 4 mm. The remaining five specimens DSC 6-6-S1 to DSC 6-6-S5 were fabricated with top and bottom plates of equal thickness of 6 mm. Stud spacing in each of these specimens were fixed in all specimens, where  $S_x = 10$  cm and  $S_y = 15$  cm, as shown in Fig. 2.

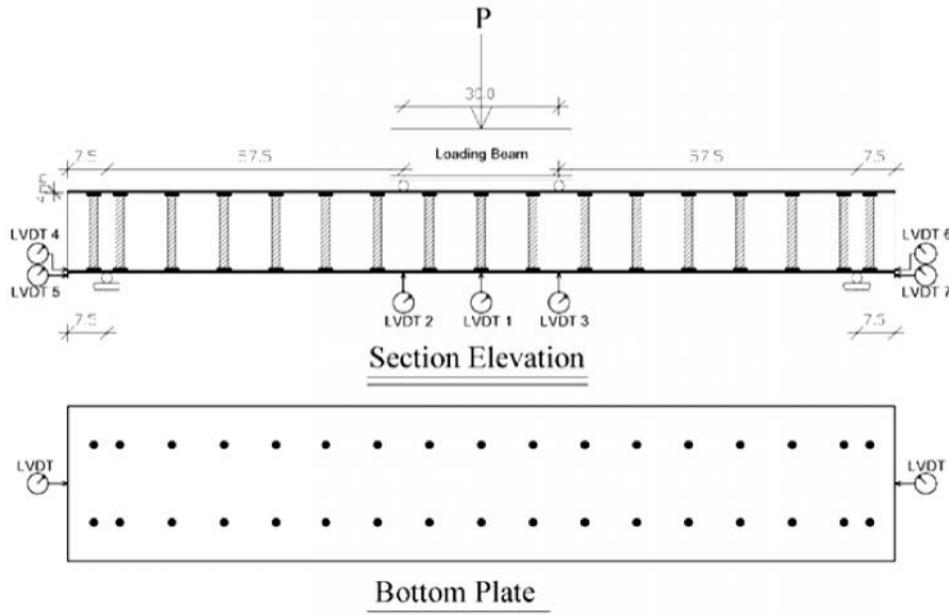
**Fig. 5. The arranged of LVDTs**

The DSC slabs to be tested was placed on two supports (hinged and roller support). Care was taken to ensure that the specimen was correctly positioned in the test frame and the center of the slab was in the line with the center of the loading head of the jack. The load was applied to the specimen by using a hydraulic jack of 100-ton capacity. A load cell of 100 ton capacity were used to measure the applied load. Deflections were measured using Linear Variable Deformation Transducers (LVDT) located at the center and under the two points load. The end slip between steel plates and concrete was measured at the end of steel plate and concrete

core, as show in Fig. 5. Before specimen loading, all strain gauges, load cell and LVDTs were connected to a data acquisition system which was programmed to record the output data. Then a small load (not exceeding 5 percent of the expecting ultimate load) was applied slowly and removed in order to eliminate any slack in the support system so that the specimen would be properly placed on the supports. This also helped to check the load cell, strain gauge and LVDTs properly.

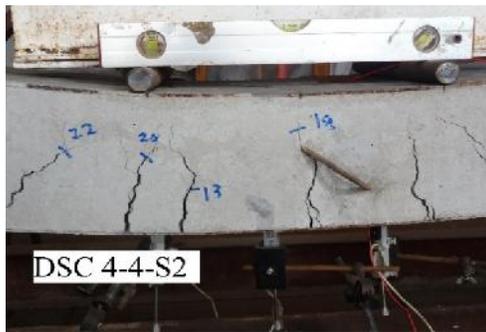
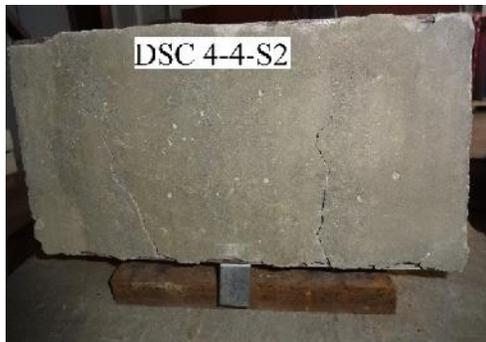
**Fig. 6. Mode of concrete cracking for specimen DCS 4-4-S2**

Two types of cracks were observed. The first type occurred due to tensile stresses at the bottom side of the specimen, especially at mid span, as show in Fig. 6-a. The second type occurred due to the mutual pressure between steel studs and concrete which causes a longitudinal splitting cracks of concrete at the studs line, as show in Fig. 6-b. For all tested specimens, both cracking types were observed. However, the first type was noted firstly then the second type was observed suddenly at failure.

(a) Wide flexural crack in concrete core

(b) Splitting cracks in concrete core

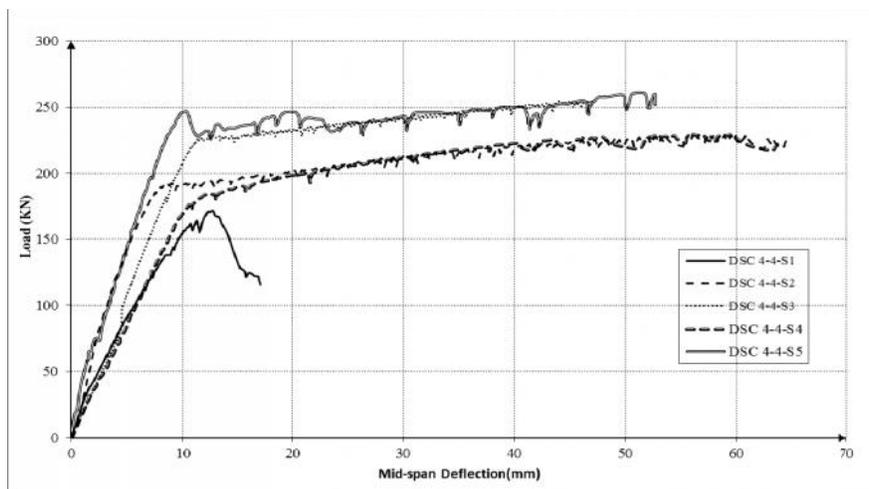
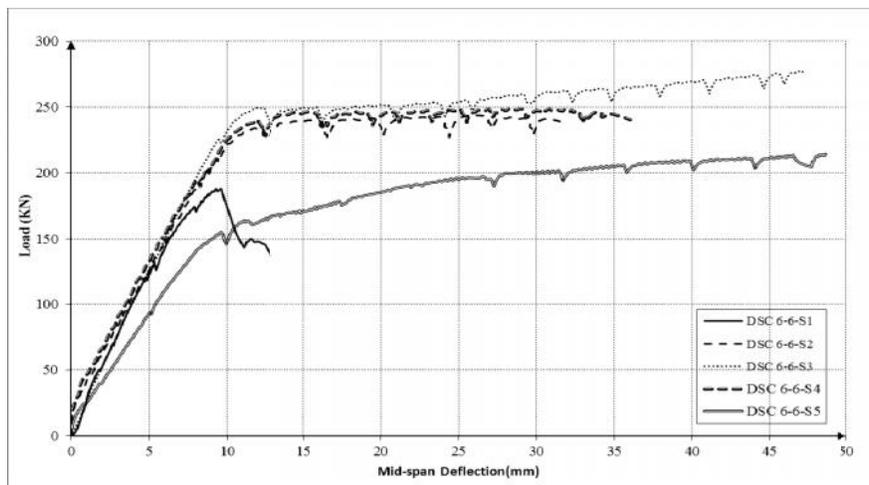
**Fig. 7. Load-deflection plot for all the tested specimens**

The measured test results for the ten specimens are summarized in Table 3. Load-deflection Plots are given in Fig. 7.a and Fig. 7.b for plates of 4 mm and 6 mm thickness, respectively.

It can be seen from Fig. 7 that load-deflection curve deviates from linear behavior after the beginning of steel plates yielding in most cases. For specimen DSC 4-4-S1, the first sign of crack appeared in the concrete when the load reached to 50 kN. A loud sound was heard indicating the breaking of shear studs when the load reached to 172 kN. After maximum load was reached, a load reduction was observed in load-deflection curve. Strain results at the mid span showed that yielding of bottom plate started when the load reached to 138 kN.

(a) Load -deflection curves for (DSC 4-4) series experimental test results

(b) Load -deflection curves for (DSC 6-6) series experimental test results

The measured load vs. deflection curves confirm that yielding of the tension plates are the most occurred failure mode.

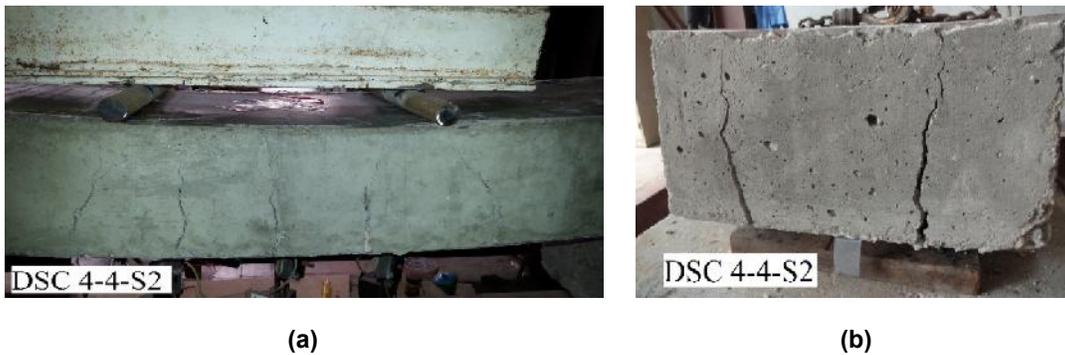
Specimen DSC 4-4-S2 compared to DSC 6-6-S2 had showed a softer behavior which is expected, at a load of 50 kN, the first sign of cracking appeared in the concrete at the mid span, then the crack were propagated and the load-deflection curve became even more flat and continued till the load failure is reached at 228 kN and deflection recorder 57 mm. The tension cracks at mid span and splitting cracks at the ends are shown in Figs. 8a and 8b, respectively. Wide cracks in the concrete at the supports indicated the presence a high pressure on concrete. 28 mm slip was observed between bottom plate and concrete at the ends.

Fig. 8. View after failure load of the specimen DSC 4-4-S2 with wide crack in concrete (a), and close up view of the right side corner showing longitudinal cracks in concrete (b)

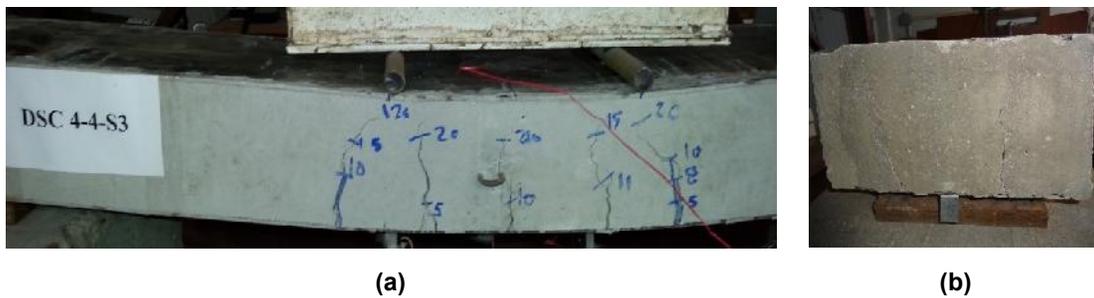
For DSC 4-4-S3, the first crack appeared in concrete when the load reached to 50 kN. Small cracks appeared in the concrete at many location of mid span, then the load-deflection curve became even more flat and continued till the load failure is reached at 260 kN and the deflection was 50 mm. The tension cracks at mid span and splitting cracks at the ends are shown in Fig. 9a and 9b, however these cracks were relatively narrow due to the low mutual pressure between concrete and steel studs as mentioned before.

Fig. 9. View after failure load of the specimen DSC 4-4-S3 with wide crack in concrete (a), and close up view of the right side corner showing longitudinal cracks in concrete (b)

The specimens DSC 4-4-S3 and DSC 6-6-S3 revealed a narrow cracks -on both side- relative to the rest of specimens as shown in Fig. 9 and Fig. 14 respectively. The large projected area of steel studs (5\*40 mm) of specimens DSC 4-4-S3

and DSC 6-6-S3 produced lesser pressure on concrete compared to the other steel studs, consequently narrow cracks were generated as mentioned.

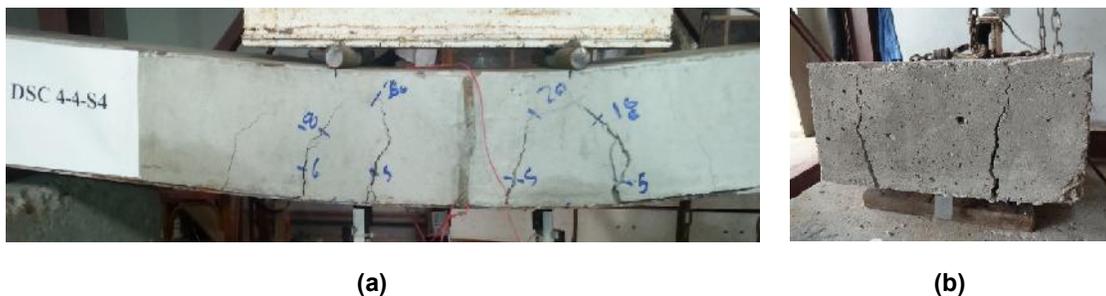
For DSC 4-4-S4, the first crack appeared in concrete when the load reached to 50 kN. Cracks appeared in the concrete at many locations of mid span then the load-deflection curve became even more flat and continued till the load failure is reached at 229 kN and the deflection was 52 mm. Splitting in concrete was also observed indicating that concentrated pressure on concrete from shear studs, as show in Fig. 10a and 10b.

Fig. 10. View after failure load of the specimen DSC 4-4-S4 with wide crack in concrete (a), and close up view of the right side corner showing longitudinal cracks in concrete (b)

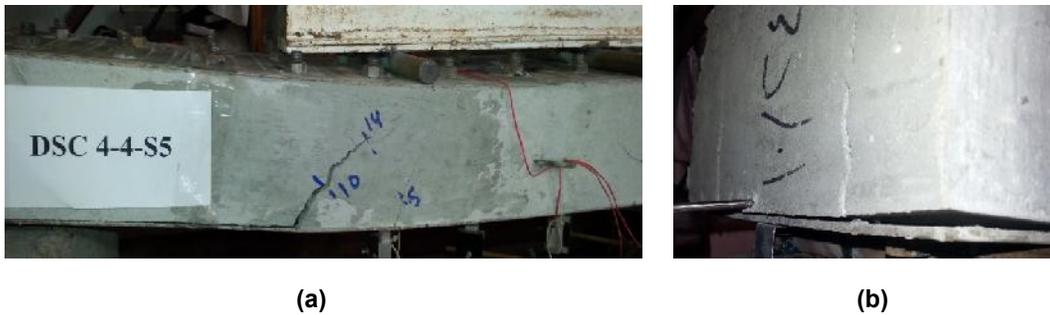
For DSC 4-4-S5, the first crack appeared in concrete when the load reached to 50 kN. Cracks appeared in the concrete at many locations of mid span then the load-deflection curve became even more flat and continued till the load failure is reached at 198 kN and the deflection was 51 mm, as show in Fig. 11a and 11b.

Fig. 11. View after failure load of the specimen DSC 4-4-S5 with wide crack in concrete (a), and close up view of the right side corner showing longitudinal cracks in concrete (b)

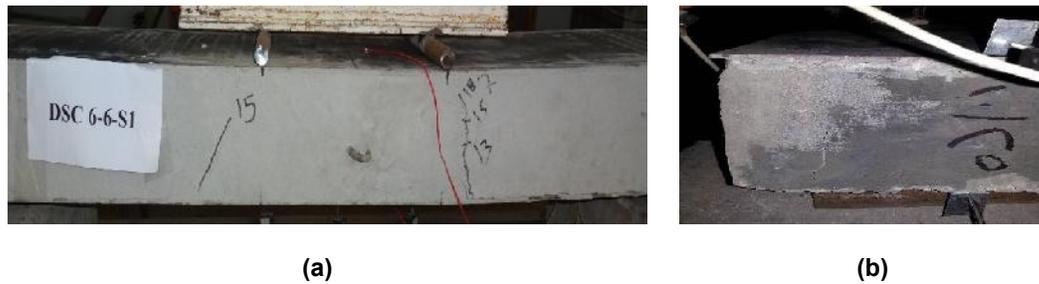
For DSC 6-6-S1, the first sign of crack appeared in the concrete when the load reached to 80 kN. A loud sound was heard indicating the breaking of shear studs when the load reached to 188 kN. After maximum load was reached, a load reducer was observed in load-deflection curve. Strain

results at the mid span showed that yielding of bottom plate started when the load reached to 132 kN, as show in Fig. 12a and 12b.

Fig. 12. View after failure load of the specimen DSC 6-6-S1 with wide crack in concrete (a), and close up view of the right side corner showing longitudinal cracks in concrete (b)

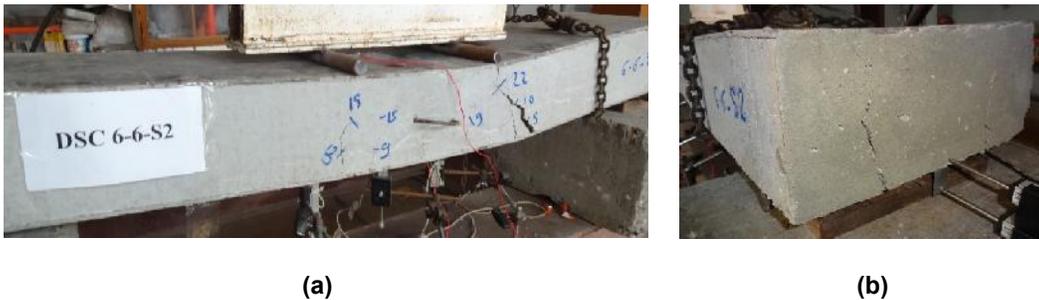
For DSC 6-6-S2, the first sign of cracking appeared in the concrete at the mid span, then the crack were propagated and the load-deflection curve became even more flat and continued till the load failure is reached at 243 kN and deflection recorder 33 mm. Wide cracks in the concrete at the supports indicated the presence a huge pressure on concrete. 16.3 mm slip was observed between bottom plate and concrete at the ends, as show in Fig. 13a and 13b.

Fig. 13. View after failure load of the specimen DSC 6-6-S2 with wide crack in concrete (a), and close up view of the right side corner showing longitudinal cracks in concrete (b)

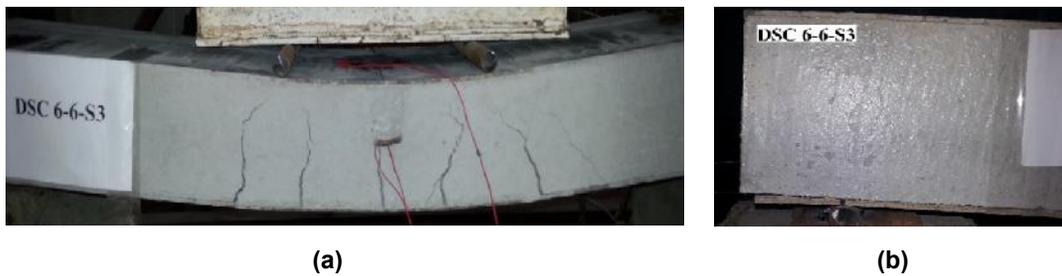
For DSC 6-6-S3, the first crack appeared in concrete when the load reached to 80 kN. Small cracks appeared in the concrete at many location of mid span, then the load-deflection curve became even more flat and continued till the load failure is reached at 276 kN and the deflection was 45 mm. The tension cracks at mid span and splitting cracks at the ends are shown in Fig. 14a and 14b, however these cracks were relatively narrow due to the low mutual pressure between concrete and steel studs as mentioned before.

Fig. 14. View after failure load of the specimen DSC 6-6-S3 with wide crack in concrete (a), and close up view of the right corner showing slide between concrete and steel plate (b)

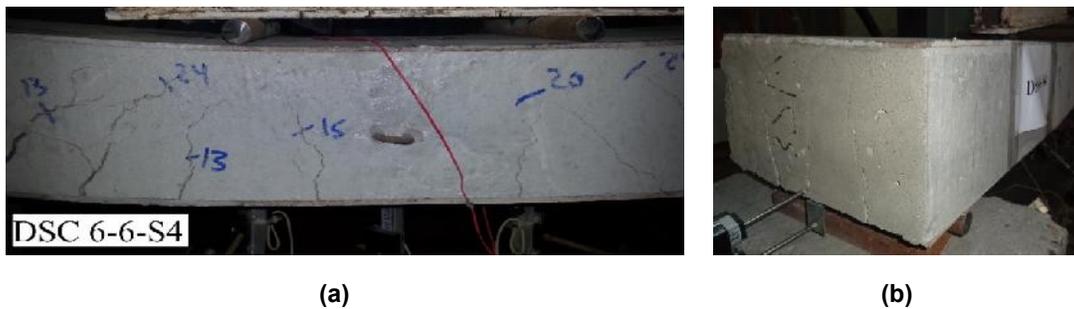
For DSC 6-6-S4, the first crack appeared in concrete when the load reached to 80 kN. Cracks appeared in the concrete at many locations of mid span then the load-deflection

curve became even more flat and continued till the load failure is reached at 246 kN and the deflection was 35 mm. Splitting in concrete was also observed indicating that concentrated pressure on concrete form shear studs, as show in Fig. 15a and 15b.

Fig. 15. View after failure load of the specimen DSC 6-6-S4 with wide crack in concrete (a), and close up view of the right side corner showing longitudinal cracks in concrete (b)

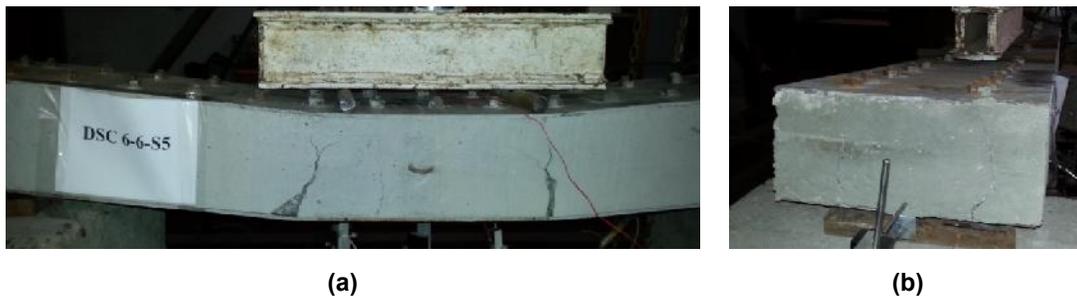
For DSC 6-6-S5, the first crack appeared in concrete when the load reached to 80 kN. Cracks appeared in the concrete at many locations of mid span then the load-deflection curve became even more flat and continued till the load failure is reached at 215 kN and the deflection was 49 mm ,as show in Fig. 16a and 16b.

Fig. 16. View after failure load of the specimen DSC 6-6-S5 with wide crack in concrete (a), and close up view of the right side corner showing longitudinal cracks in concrete (b)

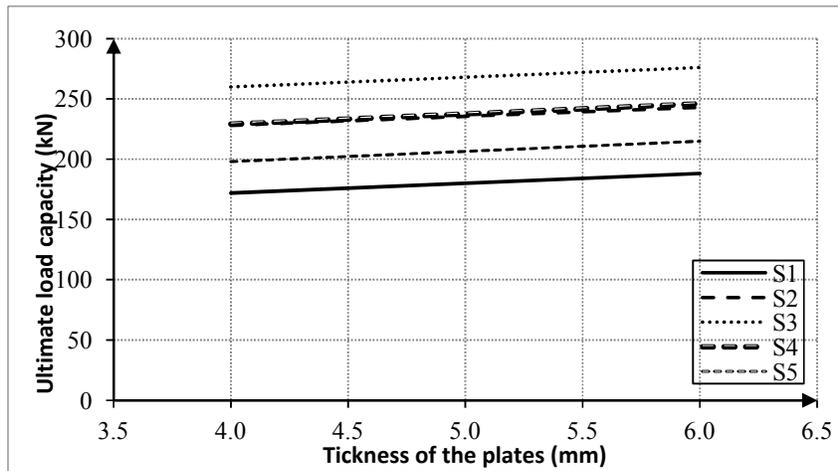
Fig. 17. Effect of steel plate thickness and shear connector type on ultimate load capacity

For all shear studs types, using steel plates of 6 mm thickness led to increase the ultimate load capacity by a range from 6.15% to 9.3% compared to specimens with 4 mm thickness, as show in Fig. 17.

It can be observed that ultimate load capacity increase with increase in plate thickness. Using steel plates of 6 mm thickness led to increase the ultimate load capacity by a range from 6.15% to 9.3% compared to specimens with 4 mm thickness.

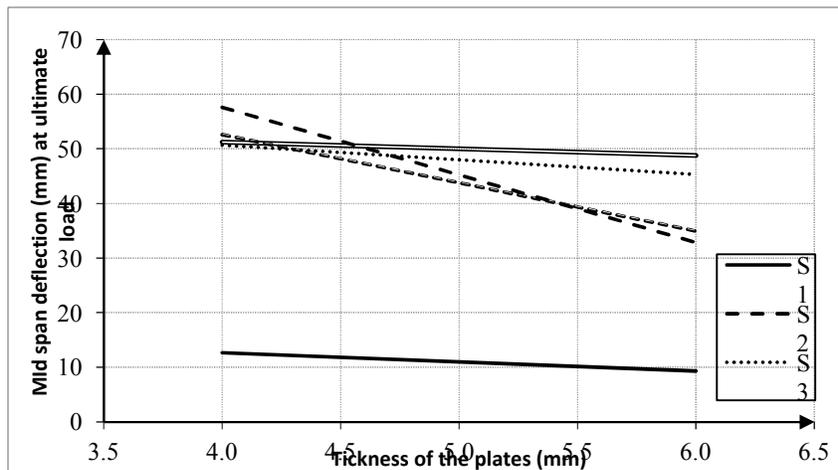
Fig. 18. Effect of steel plate thickness and shear connector type on the mid span deflection at ultimate load

For shear studs (S1, S3 and S5) using steel plates of 6 mm thickness led to reduce the mid span deflection by a range from 4.7% to 26% compared to specimens with 4 mm thickness, as

show in Fig. 18. However, higher reducer in mid span deflection ranged from 33% to 43% was obtained for specimens with shear studs S2 and S4.

It can be observed that the mid span deflection decreased with the increasing in plate thickness. For shear studs (S1, S3 and S5) using steel plates of 6 mm thickness led to reduce the mid span deflection by a range from 4.7% to 26% compared to specimens with 4 mm thickness. However, higher reduction in mid span deflection ranged from 33% to 43% was obtained for specimens with shear studs S2 and S4, when the steel plate thickness was increased from 4 mm to 6 mm.

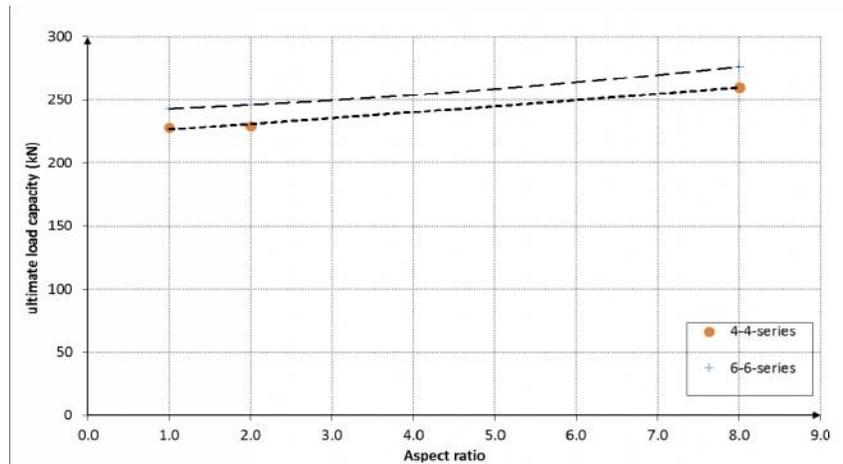
**Fig. 19. Effect of steel studs aspect ratio on the ultimate load capacity**

A significant effect of aspect ratio was observed on the ultimate load capacity y and mid span deflection, as show in Fig. 19 and Fig. 20, respectively.

Increasing the aspect ratio from 1 to 8 led to increase the ultimate load capacity by 14% and 13.6% for specimens of 4 mm and 6 mm steel plate thickness, respectively.

It can be observed that ultimate load capacity increase with increase in aspect ratio of the cross sectional area of shear studs. Increasing the aspect ratio from 1 to 8 led to increase the ultimate load capacity by 14% and 13.6% for specimens of 4 mm and 6 mm steel plate thickness, respectively. However, the mid span deflection decreased with the increasing in aspect ratio of the cross sectional area of shear studs. The mid span deflection were reduced by 12.2% and 14.1% for 4 mm and 6 mm steel plate thickness, respectively.

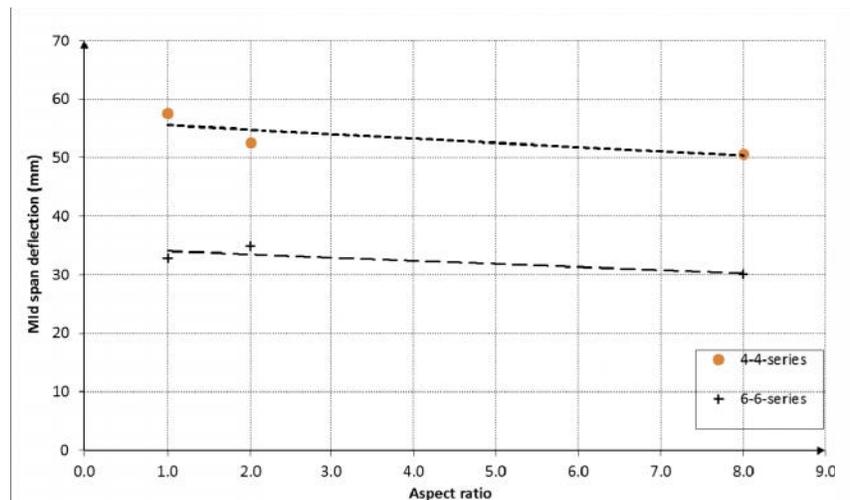
**Fig. 20. Effect of steel studs aspect ratio on the mid span deflection at ultimate load**

When the aspect ratio increase from 1 to 8, the mid span deflection were reduced by 12.2% and 14.1% for 4 mm and 6 mm steel plate thickness, respectively. Increasing the aspect ratio produces lower pressure on concrete. So, the specimens DSC 4-4-S3 and DSC 6-6-S3 are more resistant and rigid.
